## TECHNISCHE MITTEILUNG / SERVICE BULLETIN NR. 31

Benzinpumpen Distanzstück – in Verbindung mit der BCD mechanischen Benzin Pumpe (Hebelpumpe)

Fuel Pump Spacer – in connection with BCD mechanical fuel pump (Lever Fuel Pump)

Motor S 1800-1-(), LBA 4590/EN mit BCD / Sauer Benzinpumpe 05 200 401B

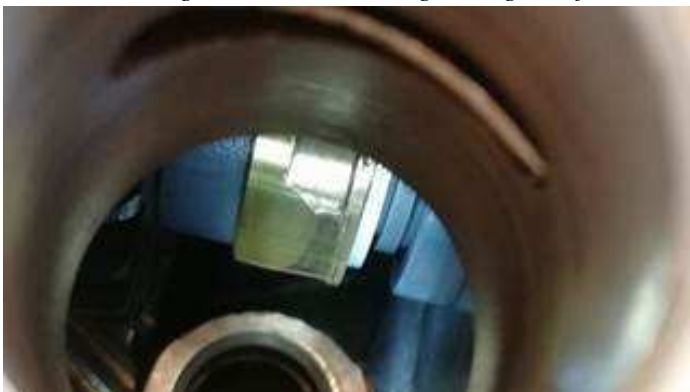
Erhöhter Verschleiß am Benzinpumpenantrieb bei Verwendung der BCD Benzinpumpe 05 200 401B, (Hebelpumpe) und des Benzinpumpendistanzstückes durch unzureichendes Spiel des Benzinpumpenhebels im Benzinpumpendistanzstück. Dieser Zustand kann dazu führen, dass der Benzindruck absinkt und der Motor bei Volllast nicht ausreichend mit Benzin versorgt wird, was zu Leistungsabfall führt.

Increased wear on the fuel pump drive when using the BCD fuel pump 05 200 401B, (lever pump) and the fuel pump spacer due to insufficient play of the fuel pump lever in the fuel pump spacer. This condition can lead to a drop in fuel pressure and the engine not being adequately supplied with fuel at full load resulting in loss of engine power.

*Abbildung des eingelaufener Exzenters des Benzinpumpenantriebes durch den Öleinfüllstutzen gesehen.  
Picture showing worn eccentric ring through oil filler.*

Wenn der Exzenterring mehr als 0,5 mm eingelaufen ist (sichtbare Abnutzung), muss dieser ausgetauscht werden. Dazu ist der Motor zur Firma Sauer zu senden. Eine entsprechende EASA Lufttüchtigkeitsanweisung wird dazu herausgegeben.

During this maintenance measure, the eccentric ring on the crankshaft must be checked for wear. This can be done through the oil filler neck on top of the engine case, or through the opening on the engine housing at the point where the lever of the fuel pump is passed through the engine case. A higher accumulation of brass particles in the oil filter is probable in this case. If the eccentric ring has run in more than 0.5 mm (visible wear), it must be replaced. The engine must be sent to the Sauer Flugmotorenbau GmbH for this purpose. An EASA airworthiness directive will be issued to address this subject.

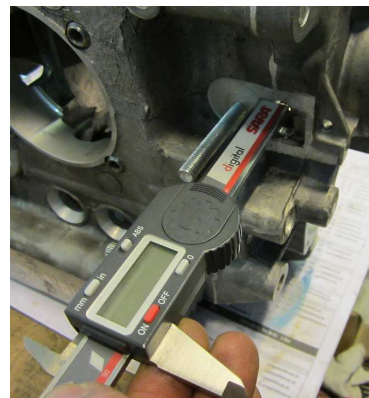
*Messen des Verschleißes des Exzenterrings  
Measuring the wear of the eccentric ring*
