## TECHNISCHE MITTEILUNG / SERVICE BULLETIN NR. 31

Benzinpumpen Distanzstück – in Verbindung mit der BCD mechanischen Benzin Pumpe (Hebelpumpe)

Fuel Pump Spacer – in connection with BCD mechanical fuel pump (Lever Fuel Pump)

Motor S 1800-1-(), LBA 4590/EN mit BCD / Sauer Benzinpumpe 05 200 401B

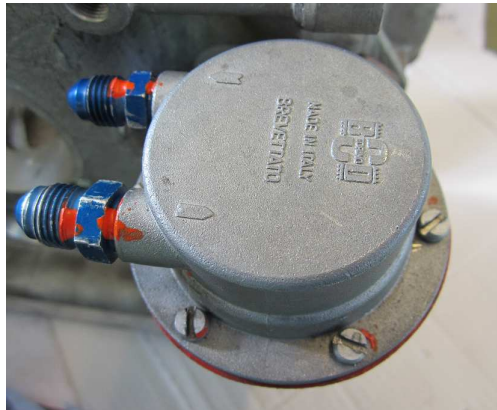
*Abbildung der BCD Hebelpumpe 05 200 401B:*

*Picture showing BCD fuel pump 05 200 401B:*

Erhöhter Verschleiß am Benzinpumpenantrieb bei Verwendung der BCD Benzinpumpe 05 200 401B, (Hebelpumpe) und des Benzinpumpendistanzstückes durch unzureichendes Spiel des Benzinpumpenhebels im Benzinpumpendistanzstück. Dieser Zustand kann dazu führen, dass der Benzindruck absinkt und der Motor bei Volllast nicht ausreichend mit Benzin versorgt wird, was zu Leistungsabfall führt.

Increased wear on the fuel pump drive when using the BCD fuel pump 05 200 401B, (lever pump) and the fuel pump spacer due to insufficient play of the fuel pump lever in the fuel pump spacer. This condition can lead to a drop in fuel pressure and the engine not being adequately supplied with fuel at full load resulting in loss of engine power.

Austausch / Erneuerung des Benzinpumpendistanzstückes 05 200 410 zwischen Motorengehäuse und mechanischer Benzinpumpe. Diese Arbeit kann vom Motorwart durchgeführt werden. Hierzu ist die Benzinpumpe zu demontieren und von Dichtungsresten zu säubern. Danach ist das Benzinpumpendistanzstück vom Motorengehäuse zu lösen und das Motorengehäuse an der Position von Dichtungsresten zu säubern. Das Benzinpumpendistanzstück ist im Austausch an die Firma Sauer Flugmotorenbau GmbH zu senden. Das neue Benzinpumpendistanzstück und die Kraftstoffpumpe ist dann gemäß Arbeitsanweisung 06022020 der Firma Sauer zu montieren.
